TECHNICAL REPORT REMR-CO-3

CASE HISTORIES OF CORPS BREAKWATER  
AND JETTY STRUCTURES

Report 8

LOWER MISSISSIPPI VALLEY DIVISION

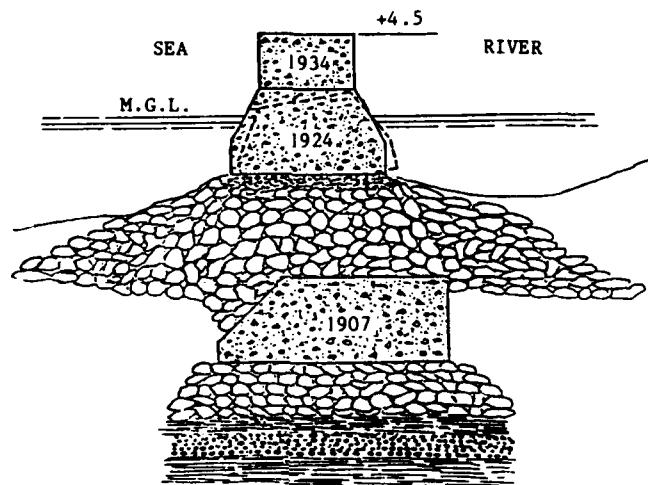
a. Cumulative work up to 1937 at 180+00

1924- 1937	During this period the jetties were maintained by placing concrete capping and riprap stone (usually as a base for capping). As a result of continued jetty subsidence, capping was required to maintain flow between the jetties. During this period, most sections of both jetties were capped twice with roughly 70,000 lin ft of concrete placed over approximately 32,000 lin ft of active jetty. (Landward ends were essentially landlocked and required no additional work.) Concrete was placed to an elevation of +4.5 ft mhw (or +5.5 ft mgl) in lifts typically 3 to 4.5 ft high. Widths of the cap varied from about 6 ft at the seaward ends to 3 ft at the landward ends. The total cumulative cost for capping and stone was \$1,170,000. In 1937, additional spur dikes were placed along the outer 10,000 ft of the jetties, reducing the effective channel width to about 1,400 ft. This addition was done in an effort to entirely eliminate maintenance dredging. Figure 13a is an east jetty cross section of cumulative work done up to 1937 in the general vicinity of 180+00.

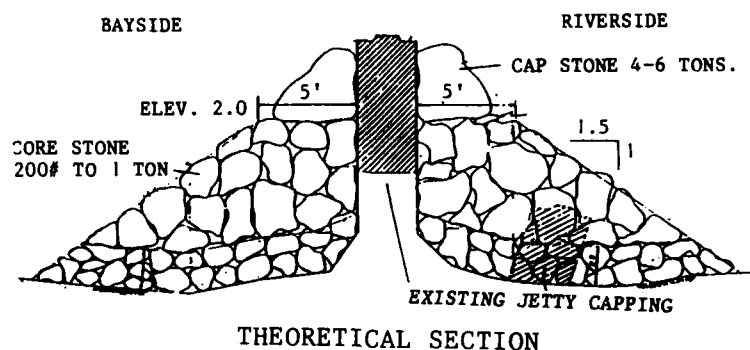
b. Buttressing of concrete cap, 1960-1961

1960	Repairs were made to the 3-ft-wide concrete cap section of the west jetty by resetting the blocks that had been dislodged during storm waves of 18 November 1957 and 16 February 1959. About 1,315 lin ft of cap was reset and buttressed with additional stone at sections 48+40 to 50+50 and 131+50 to 143+00. The design cross section (Figure 14b) used to supplement the concrete blocks consisted of a 2-ft-thick bedding layer of 25- to 200-lb stone, followed by 200- to 2,000-lb stone placed to +2 ft mlg (1V:1.5H side slopes and a 5-ft width on either side of the cap), and 4- to 6-ton stone was placed on either side of the cap. The principal purpose of buttressing was to provide a more stable cross section for the concrete blocks. The cap sections were buttressed with 16,400 tons of stone at a cost of \$173,600.

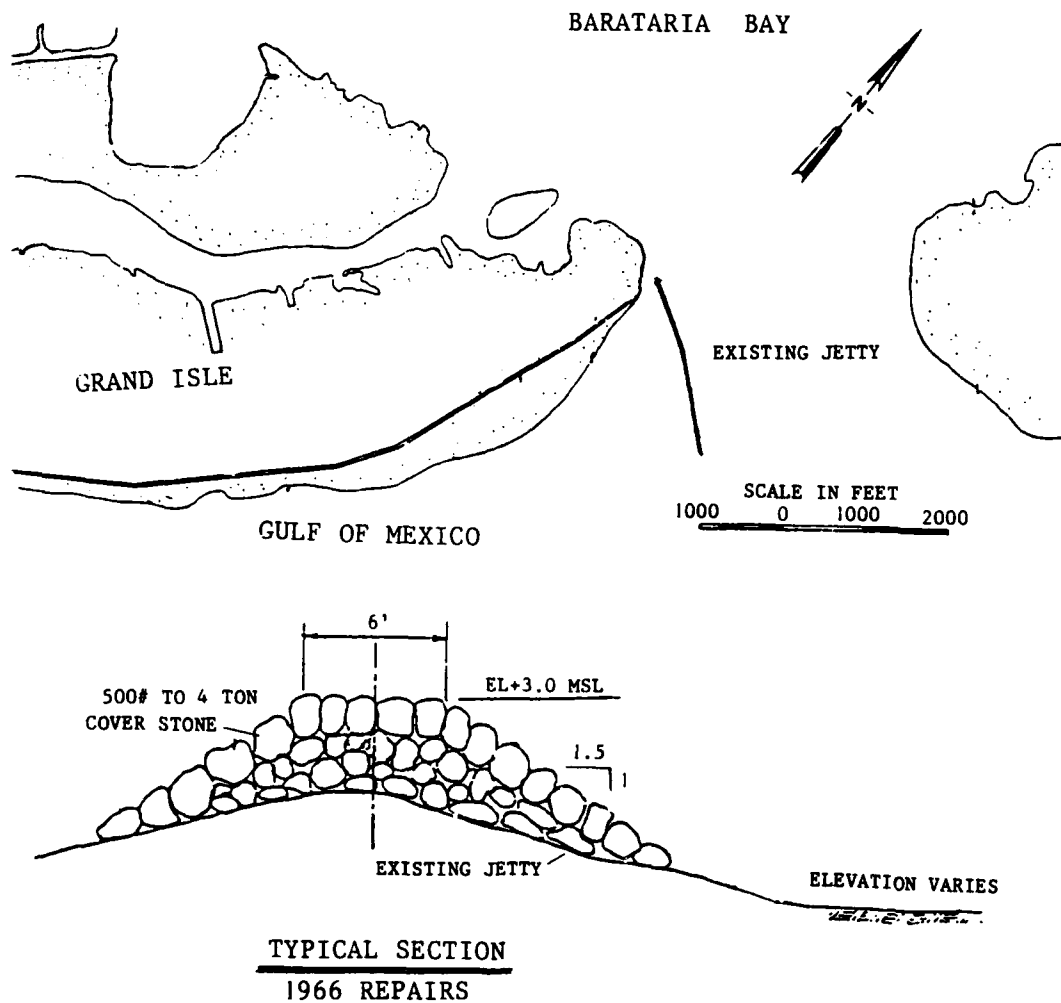
Figure 18. Plan view of Grand Isle jetty and  
typical 1966 repair section

<u>Date(s)</u>	<u>Construction and Rehabilitation History</u>
1958 1959	The jetty was constructed by the Louisiana Department of Public Works approximately 1,000 ft west of the eastern end of Grand Isle. The jetty was approximately 935 ft long. It was founded on a timber mattress and had a 6-ft crown width with 1V on 1.5H side slopes.
1964	The jetty was extended 1,400 ft by the State of Louisiana with essentially the same cross section used for initial construction.
1966	The jetty at the east end of Grand Isle (west side of Barataria Pass) was repaired with shell and stone (Figure 18). Existing center-line elevations (October 1965 survey) varied from -8.5 to +3 ft mean sea level (msl). The repairs were carried out along 2,320 ft of the jetty from 2+60 to 25+80 (seaward end). The landward end of the repair section was approximately 200 ft from the existing shoreline. The design section (Figure 18) called for a +3 ft msl crown elevation (+4 ft msl on landward 340 ft), a 6-ft crown width, and 1V:1.5H side slopes. A bedding layer of shell was placed at two sections, 12+90 to 14+20 and 15+80 to 16+60. A total of 7,500 tons of 500-lb to 4-ton stone and 770 cu yd of shell was placed at a total cost of \$83,500. After the jetty repairs, the State of Louisiana placed about 200 lin ft of sand dike between the existing shoreline and the landward end of the jetty. The dike was to have a crest elevation of +8 ft, and additional shell and 25- to 1,000-lb stone were to be used at the jetty junction. The cost for the dike was to be reimbursed by the Federal government (no details).
